FIBERGLASS PARTS PLANT FINDS SAVINGS BEYOND THE AIR COMPRESSOR ROOM

By Ron Marshall for the
Compressed Air Challenge[®]

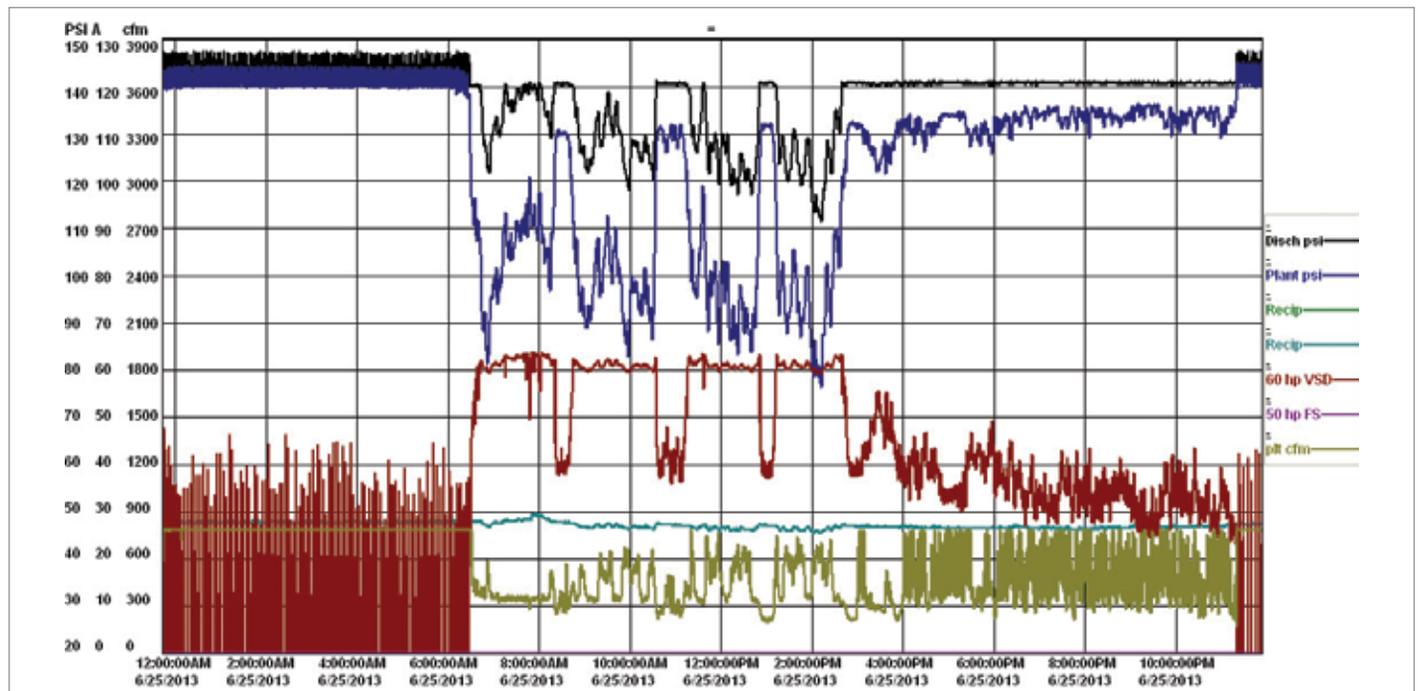
Figure 1: Even with very high air compressor pressure, the plant pressure was inadequate due to component failure.

was a 20-psi pressure differential across the contaminated after-cooler and flow controller. The data also showed that the regulator was no longer accurately controlling the pressure due to internal problems. In addition to this, the peak plant demand was exceeding the capacity of the available air compressors, allowing the system pressure to drop below the lowest levels required for critical production machinery. An increase in capacity was required.

From the initial data logging, the problem with the clogged cooler and malfunctioning flow controller was very obvious. The cooler was removed and regulator bypassed. Surprisingly,

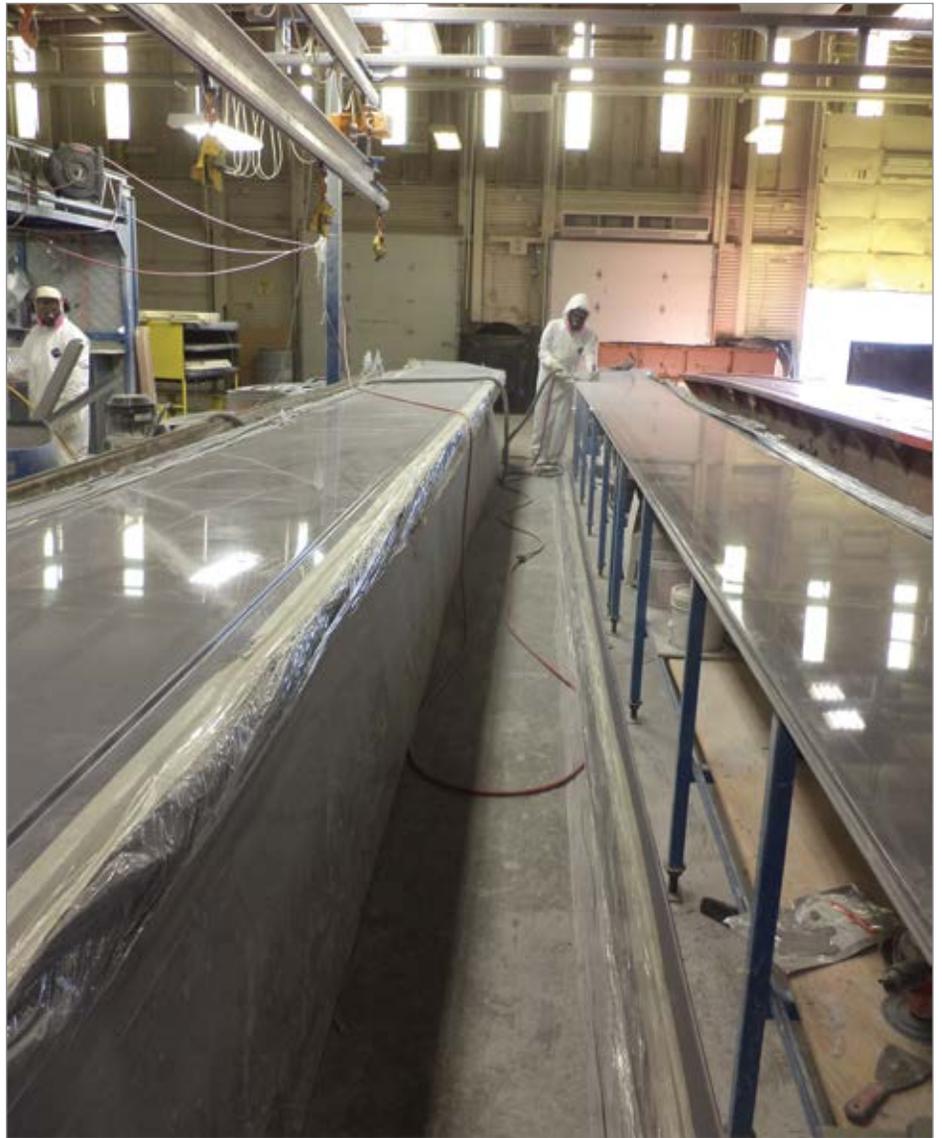
Figure 2: Hose selection and poor connection practices cause poor compressed air tool performance.

however, this did not completely solve the problem with poor tool performance. Further investigation was done at the end use, and found a poorly designed supply system feeding this most critical cutting tool. A special test was performed to measure the pressure gradient in the supply lines using a T connection with a test gauge. The test gauge was inserted into the line directly before the

final tool connection. With no tool operation, the line pressure was at 118 psi, but once the tool trigger was pulled and the unit started operating, the input pressure fell to 44 psi. Since the rating of the tool is 90 psi, poor performance was a result.

In looking back towards the system to the main header, the hose system feeding the tool consisted of a total of four standard

1/4-inch quick connect couplings at various points and a 50-foot section of 1/4-inch hose mounted on a hose reel. A hose of significant length is required to provide sufficient mobility to reach all locations along the length of the large molds. Calculations confirmed the expected pressure differential of this configuration. The hose system was undersized.

- Critical tool hosing was upgraded to 3/8 inch, and the number of quick-connect couplers was reduced to one

full-flow connector. The cutting tool now sees 90-psi operating pressure.

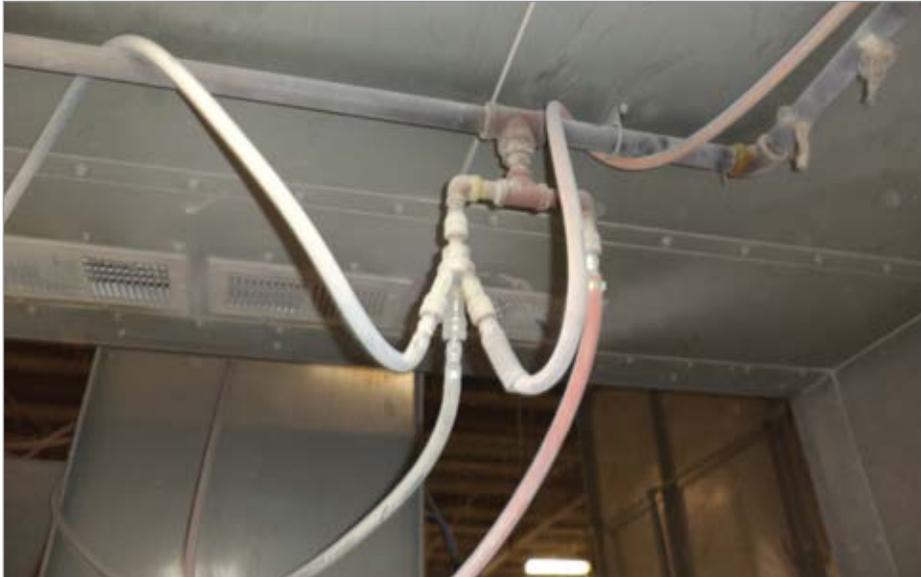
Figure 3: Questionable connection practices caused huge pressure differentials in some areas.

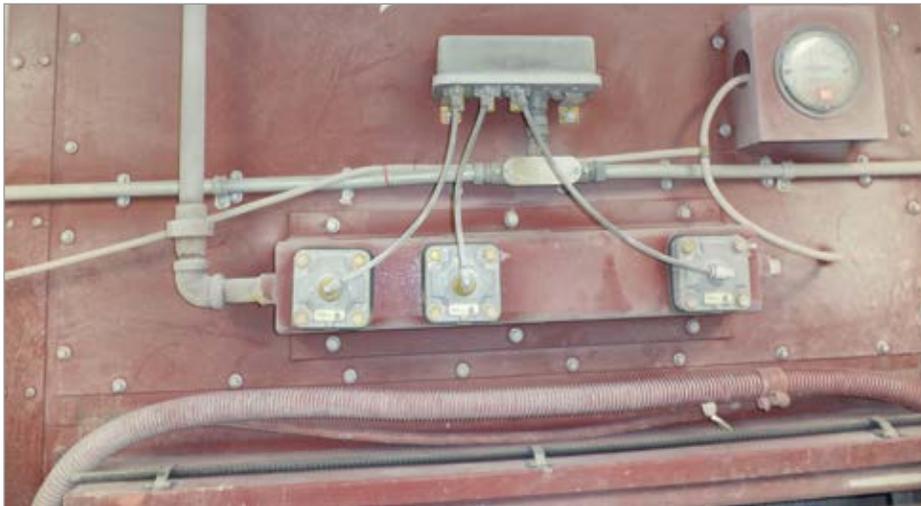
Figure 4: Poorly adjusted pulse filter cleaning system wasted compressed air

“A significant waste of compressed air was found in the grinding area where pulse-type cartridge filter cleaners had been adjusted incorrectly. Instead of sending a cleaning pulse of compressed air every few minutes, the sequencing timer had been adjusted to pulse every 2 seconds.”

- Leakage was repaired and mixers turned off on the weekend. Pulse cleaners were outfitted with receivers to boost pulse force, allowing a reduction in operation frequency and saving compressed air.

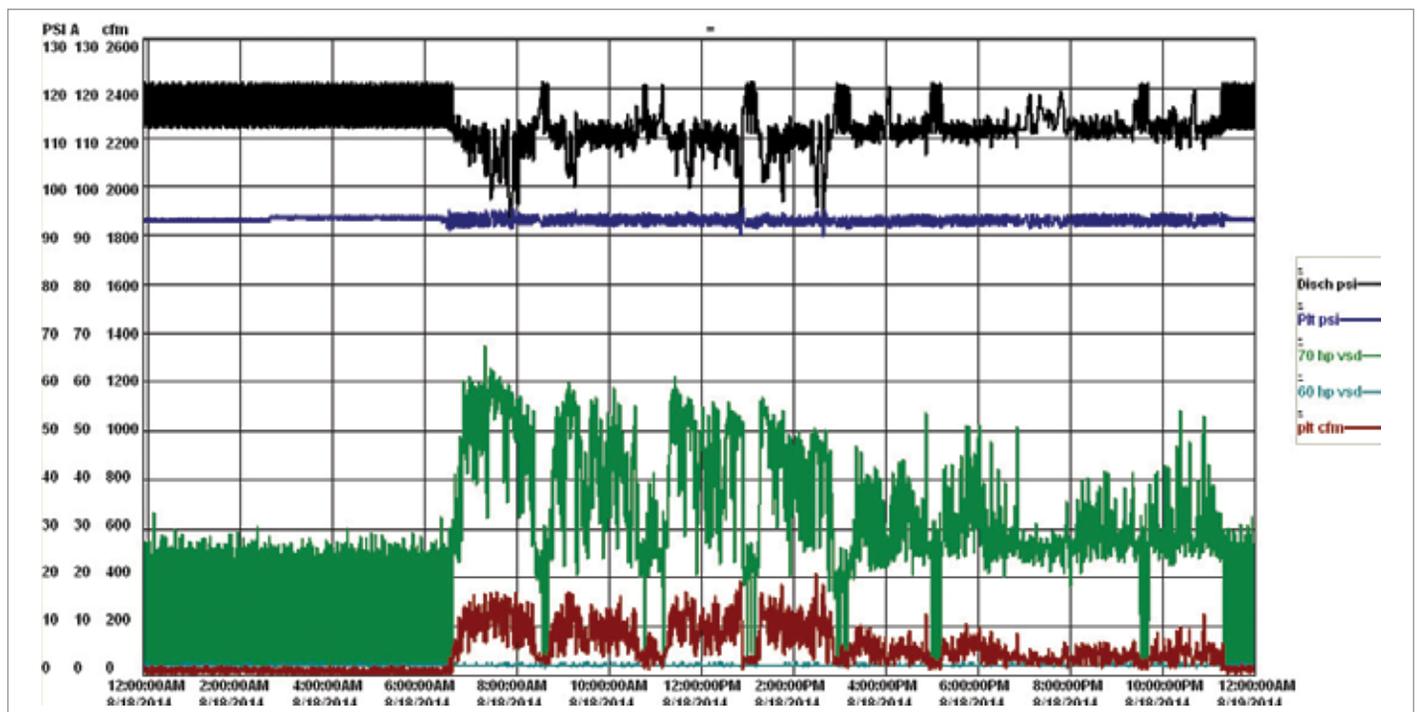
Figure 5: Plant pressure and compressed air flow during the off hours were greatly improved after the projects.

As a result of the improvements, the compressed air system, the room heater, and the vacuum system energy consumption has been reduced by 48 percent for savings worth

\$17,500 per year. This project qualified for a substantial utility incentive of \$32,000 with a calculated payback of 4.4 years, not including the increased plant productivity.
